**GEOLOGICAL HAZARD EVALUATION**

**SITLA PROPERTY  
INTERSTATE 15, MILEPOST 13**

**WASHINGTON, UTAH**

**PROJECT NO. 2031291**

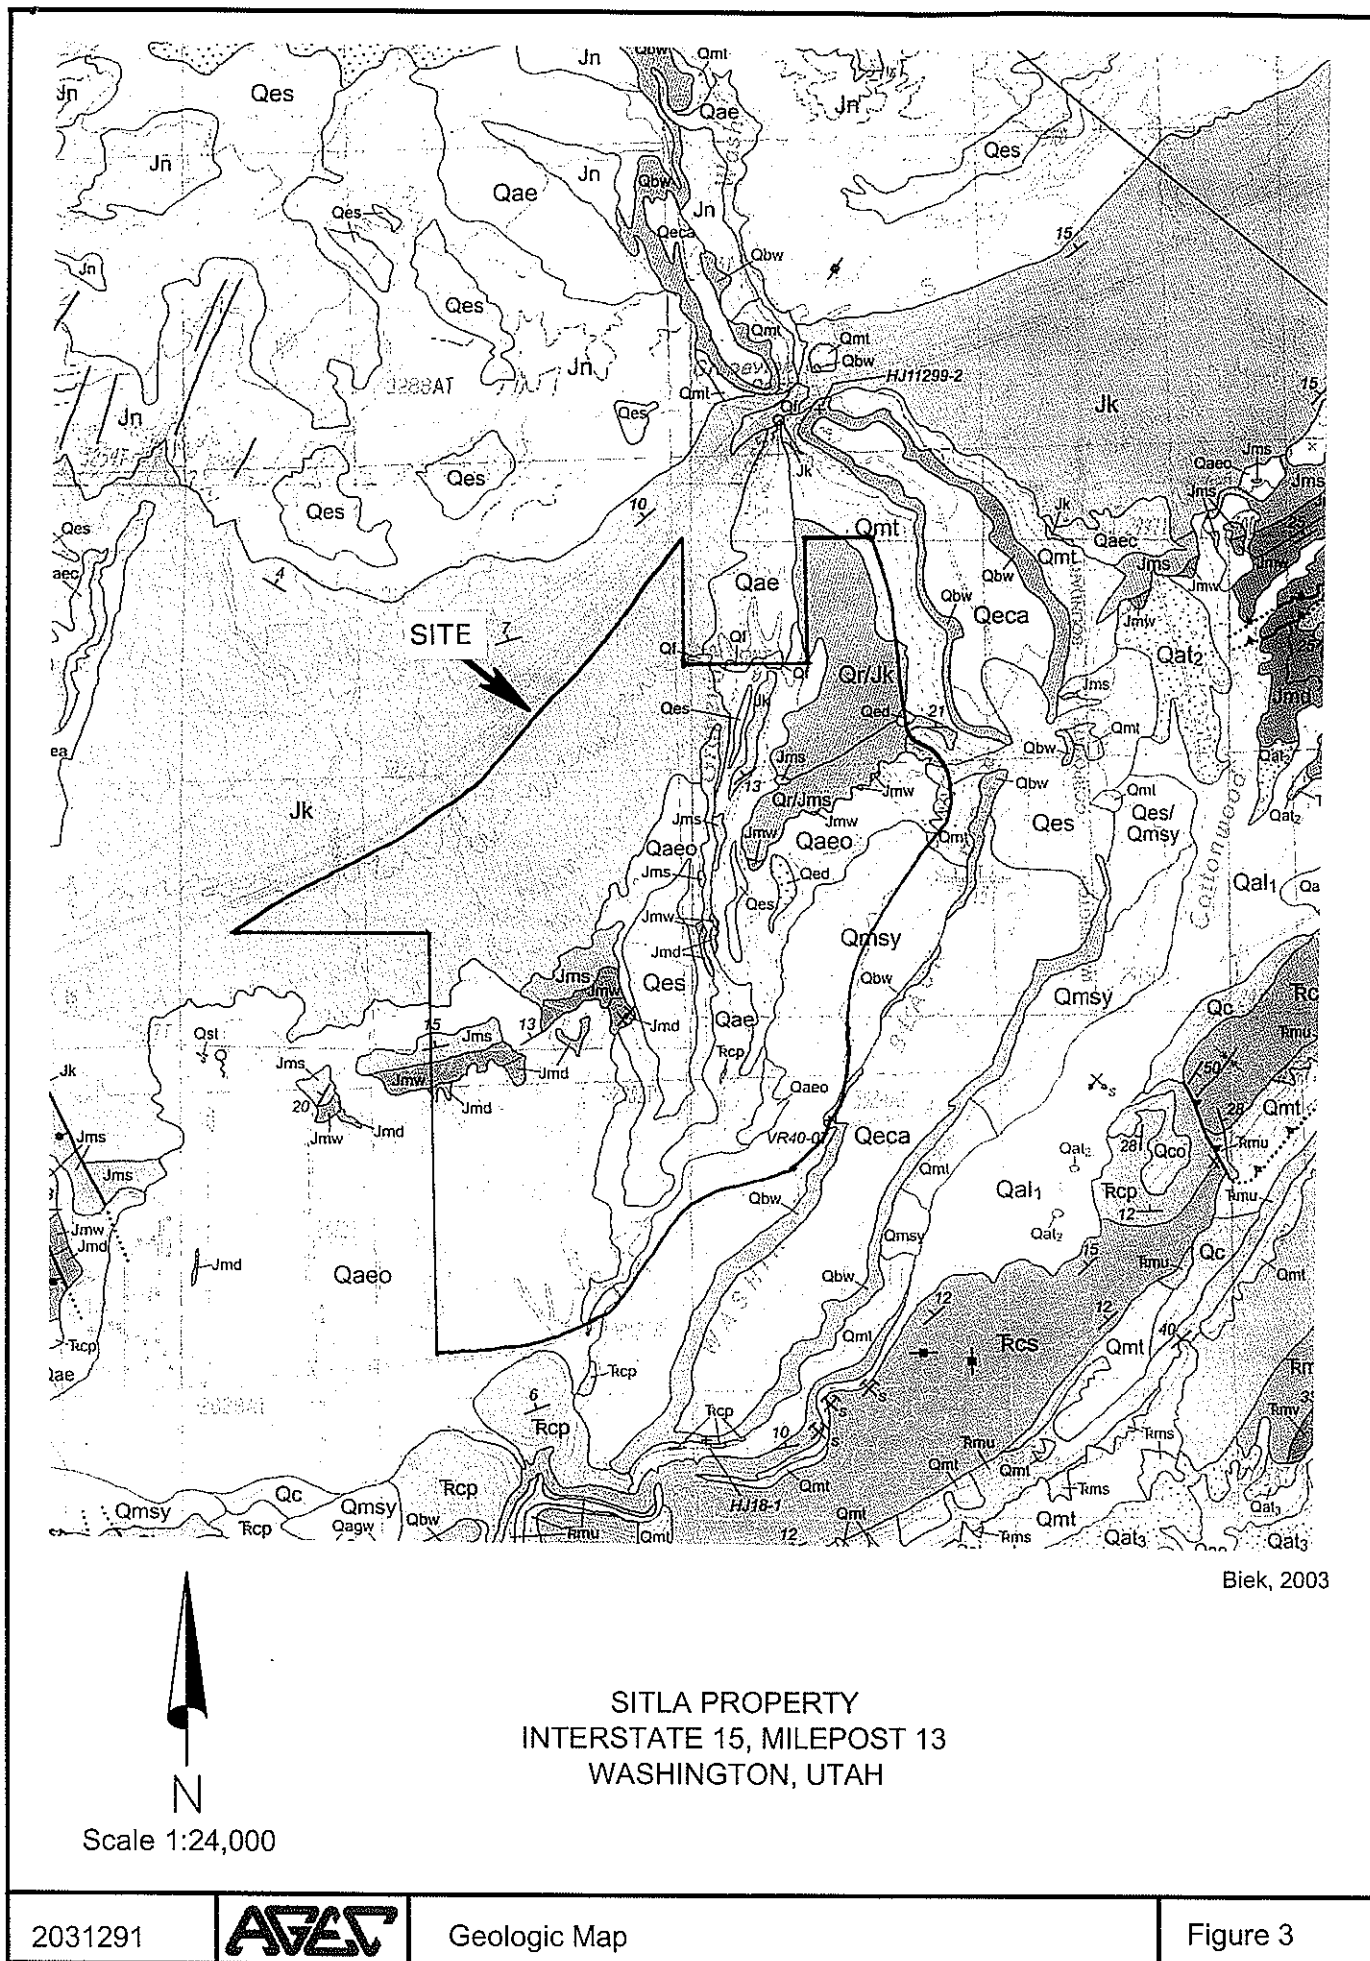
deposits (Figure 3). Terrain with hummocky surfaces and various scarps and terraces usually associated with landslides were observed in this area during our site reconnaissance. According to Biek, most of the movement in these slides took place in the Pleistocene era. Changing slope configurations (grading to remove the toe of the slope or loading the slope with fill) and the introduction of water into the subgrade could result in increased landslide potential.

Rock-fall deposits are mapped on the northeast edge of the site along the western slope of the Washington Black Ridge (Figure 3). Site reconnaissance and field mapping found that these deposits are not particularly thick. The rock-fall deposits consist of basalt cobbles and boulders. Rock-fall hazard at the site appears to be the result of weathering of the less resistant Kayenta Formation which underlies the basalt flow near the northeast corner of the site.

- Much of the west slope of the Washington Black Ridge, which lies along the eastern edge of the subject site, is mapped as an ancient landslide area. Slump features were observed within this area. Stability analysis should be performed for development of these areas. Recommendations including drainage and slope configuration (grading) can be provided to reduce risk of landslide.

- The majority of the rock-fall hazard at the site appears to be limited to the northeast corner of the site. Additional rock-fall hazard was observed along the eastern edge of the site (west slope of the Washington Black Ridge). The majority of the rock-fall hazard south of the northeast corner of the property appears to be minor due to the distance of the crest of the ridge from the property limits and the more gradual slope in these areas. Additional study could be performed to evaluate the rock-fall hazard if development is planned in these areas. This would allow the recommendation of options such as avoidance of the hazard, removal of the hazard, or construction of a

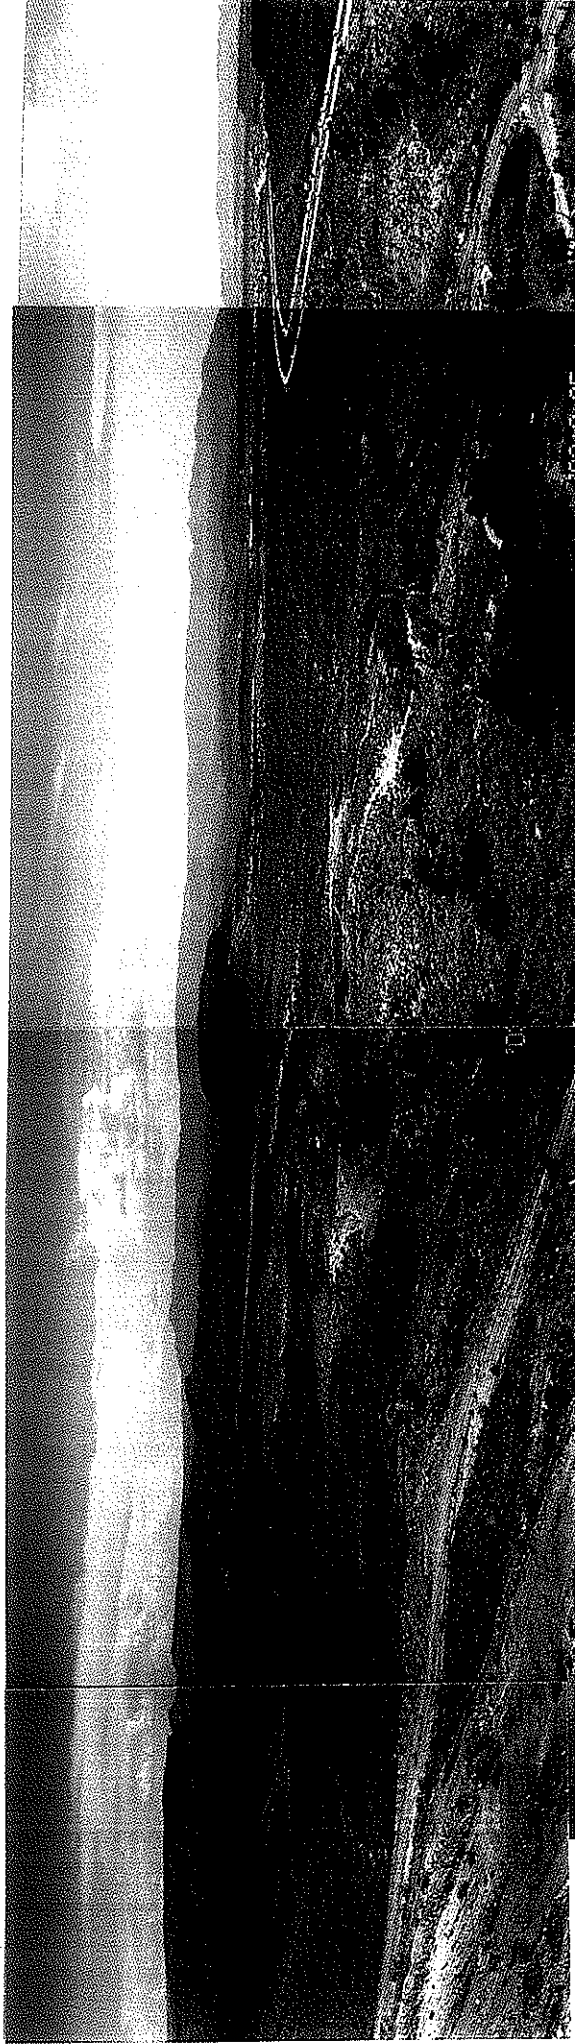
A small concrete masonry unit (CMU) building was observed near the northeast corner of the site (Photo Exhibit 1). The building does not have a roof and is not currently occupied. Several small earthen dams were observed on the northeast corner of the site. A small amount of water was observed behind one of the dams. The others were dry at the time of the site visit.

**Photo Exhibit 1:** View of subject site looking to the southwest. The Washington Black Ridge is visible to the left. Interstate 15 is to the right. A concrete masonry unit structure can be seen on the bottom right.

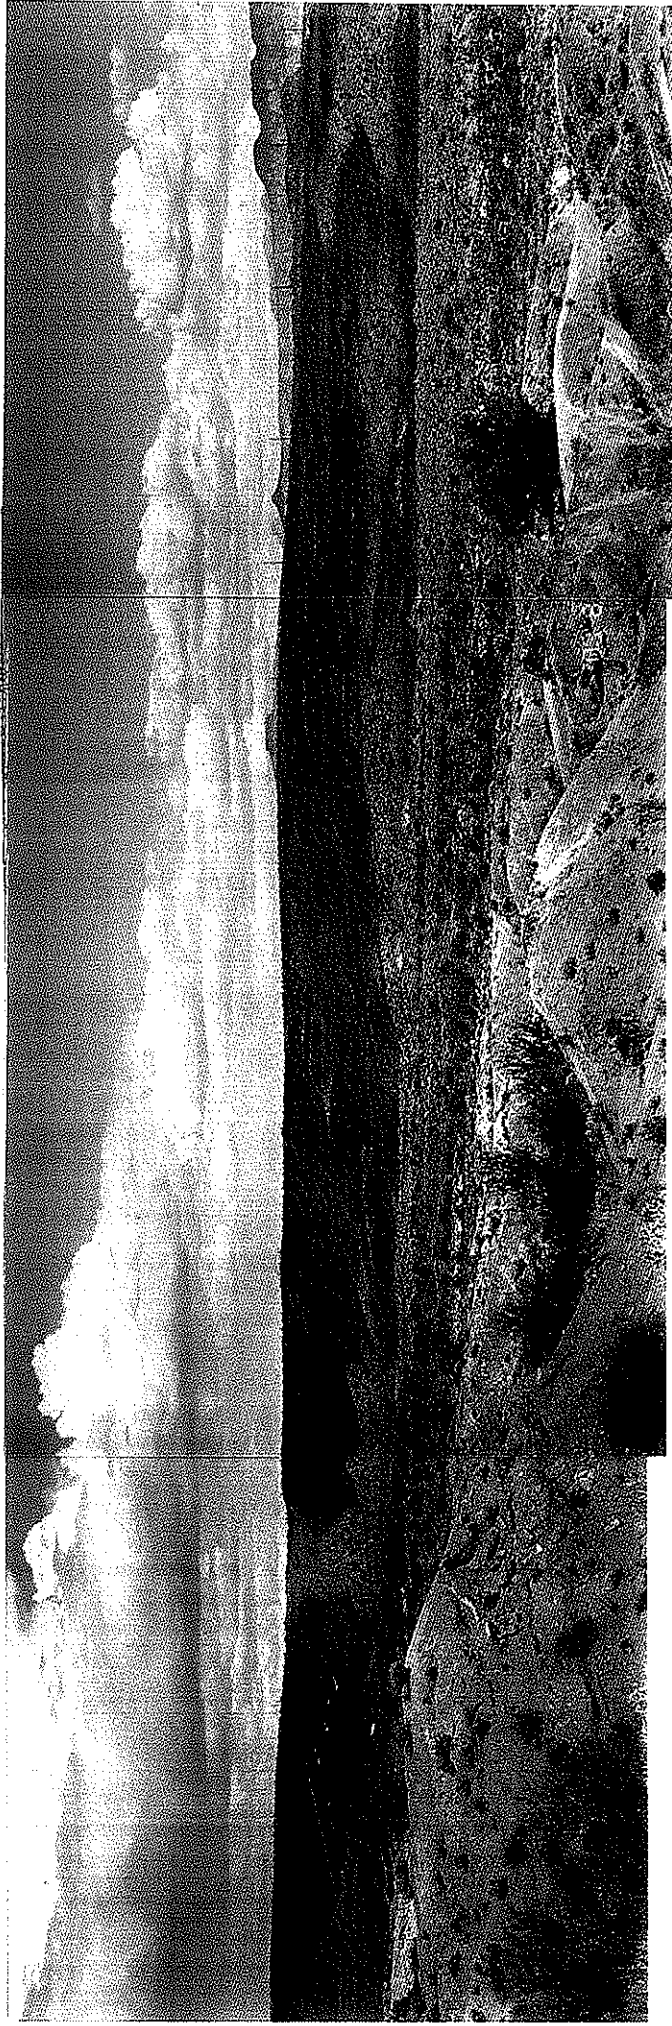
Photo Exhibit 3: View of the south end of the eastern edge of the site. View is looking to the east.

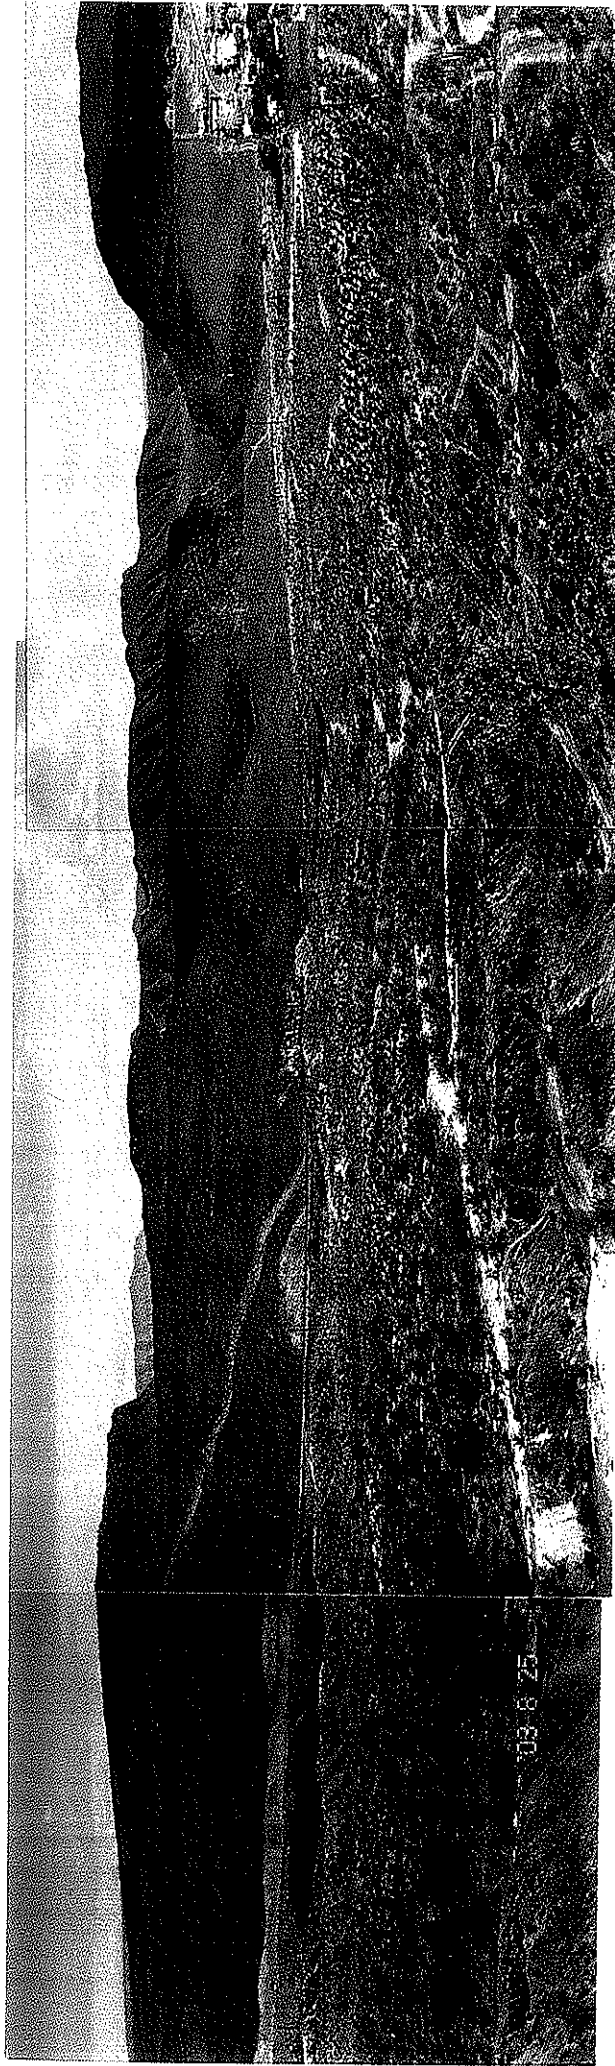
Several residential subdivisions are located to the south and southwest of the subject site (Photo Exhibit 4). A small commercial development is located adjacent to the southwest corner of the site.

**Photo Exhibit 4:** View of the southern end of the subject site. Telegraph Street is visible in the center. English Oaks and Ridge Point residential subdivisions are on the right. The fence to the right appears to be the west property line. View is looking to the south.
